CENTRAL UTAH RELOCATION CENTER (TOPAZ) WAKASA MEMORIAL STONE ASSESSMENT REPORT

December 14, 2022

Wakasa Memorial Stone

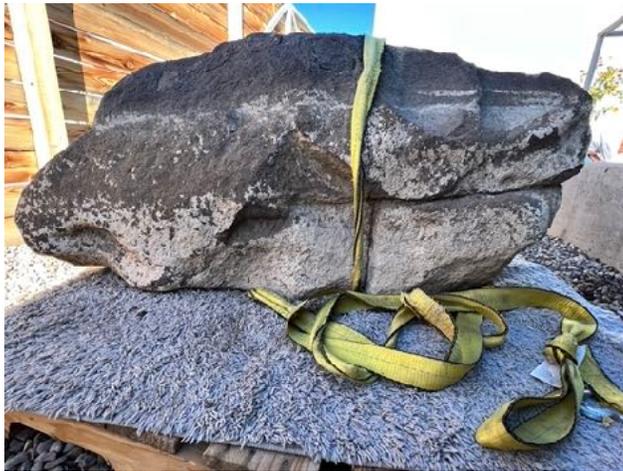
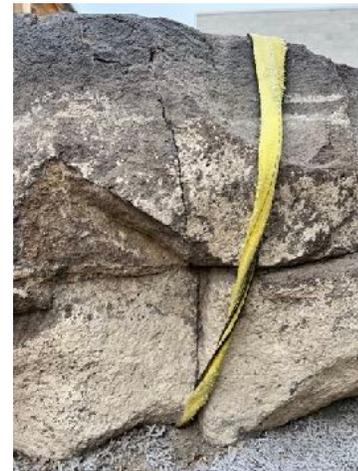
- A) The **south side** is characterized by the presence of substantial cracks and natural fissures that intersect forming approximately 90 degree angles in a cross shape (+). The stability and cohesiveness of these fissured areas is of concern. It is this surface that was facing predominantly skyward during its approximate 80 years at Topaz. Facing skyward for this amount of time likely facilitated the puddling of water from rain, stone and ice in and around the cracks. Gravitational forces likely facilitated water infiltration into these fissures. Water expands approximately 8-9% in volume when frozen. As a consequence, repeated freezing and thawing cycles exerts substantial expansive force in fissures, which often result in a weakened and less cohesive stone. It is not known to what extent distress may have been caused from this process in the subject stone.

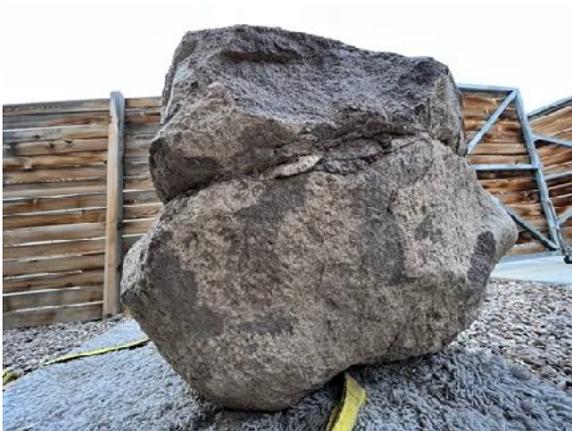
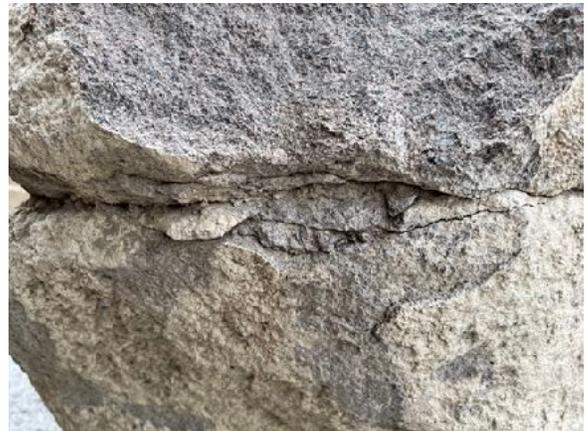
- B) The **east side** is characterized as constituting the east “end” of the stone. It has a substantial horizontal crack across its entire end that extends from the + crack on the south side.

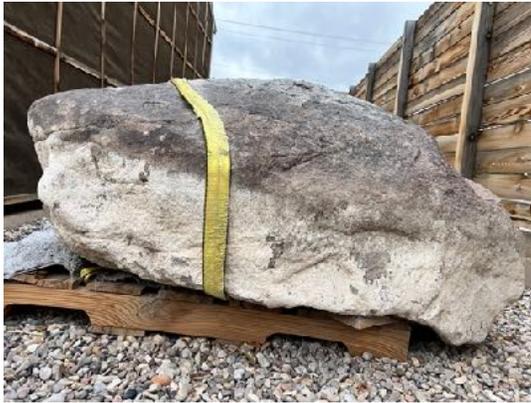
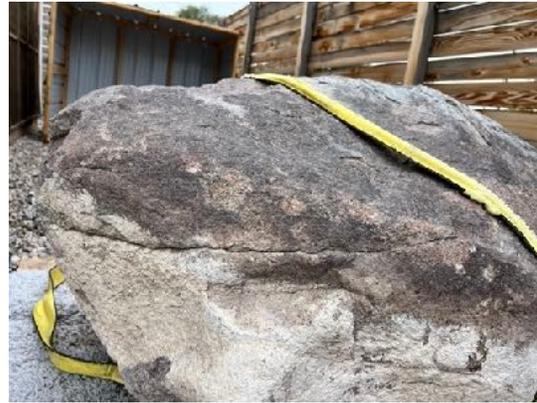
- C) The **north side** is characterized by a continuation of the horizontal crack from the east side. This crack is located near the upper level of the north elevation. It fades and terminates approximately 1/2 the distance across the north side of the stone. The lower 1/2 of the north side is covered with caliche and the remaining top 1/2 is desert varnish.

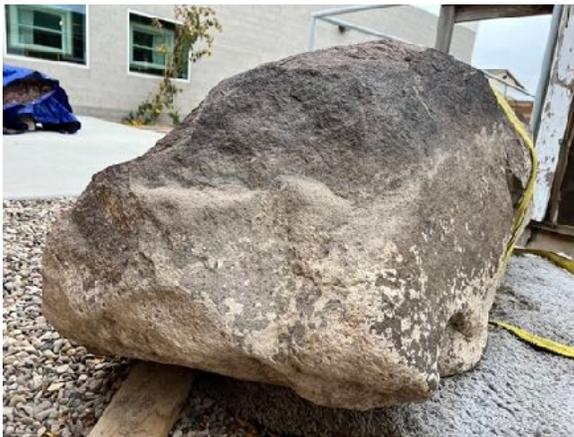
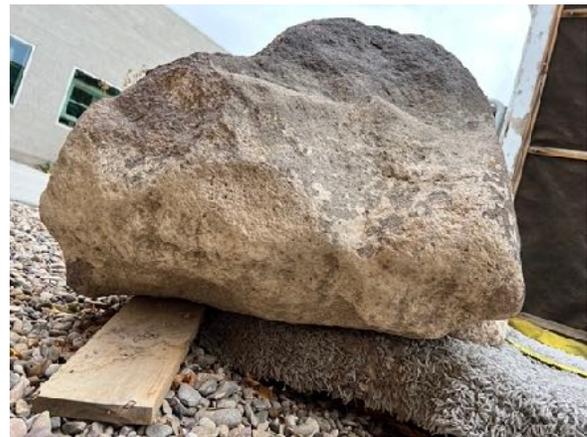
- D) The **west side** constitutes the west “end” of the stone. The defining feature on the west side is a large awkward downward bend on the end of the stone. This unexpected dropped shape created difficulty dislodging the stone from the ground during unearthing. The downward pointing bend extends off the west end of the pallet and below the top surface of the pallet, and is not currently supported except by a wood board the equipment operator placed at an angle under it - likely to keep the stone from rocking during loading, transporting and unloading.

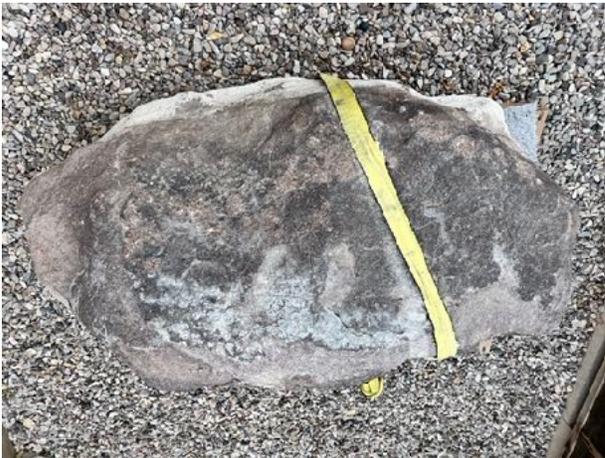
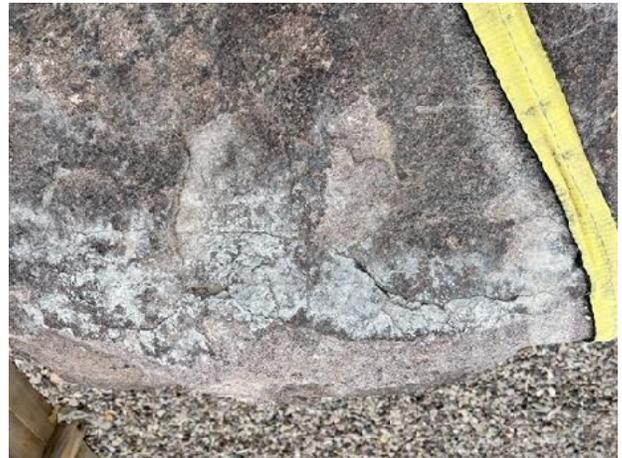
- E) The **skyward facing surface** consists primarily of “desert varnish.” Desert varnish is described by Eric H. Christensen, Professor of Geology at Brigham Young University in Provo, Utah as a dark iron-manganese deposit formed by the rock surfaces being exposed to the atmosphere in arid and semi-arid environments. There is a significant amount of surface loss on this surface. I “sounded” the skyward / desert varnish surface by lightly tapping it with the end of hand held metal rods and listening to the resulting sounds. Areas sounding higher in pitch are typically cohesive, while areas sounding lower in pitch typically indicates hollowness or separation of layers. Based on the results of the sounding, large areas of the desert varnish surface appear to have developed hollowness, delamination or other distress. This condition is typical of many skyward facing stone surfaces. The condition also preceded the unearthing and relocation of the stone.

- E) It is quite likely the current top side of the stone where the desert varnish is predominant sustained surface loss as a result of the unearthing and relocation of the stone. As the stone was being tugged via the yellow strap while dislodging it from the soil in the bottom of the hole, the stone rotated which resulted in substantial areas of the desert varnish coming in direct contact with the silty soil at grade. It was in this position that the stone was dragged toward the road prior to it being loaded. Page 27 of the January 2022 NPS report states that “stone fragments found at the site where the stone was removed match the color and texture of areas on the main body of the stone that exhibit evidence of loss.” See photos 16-19 of the NPS report. I do not know if the referenced stone fragments were collected by the NPS personnel. Neither do I know where they are currently located.

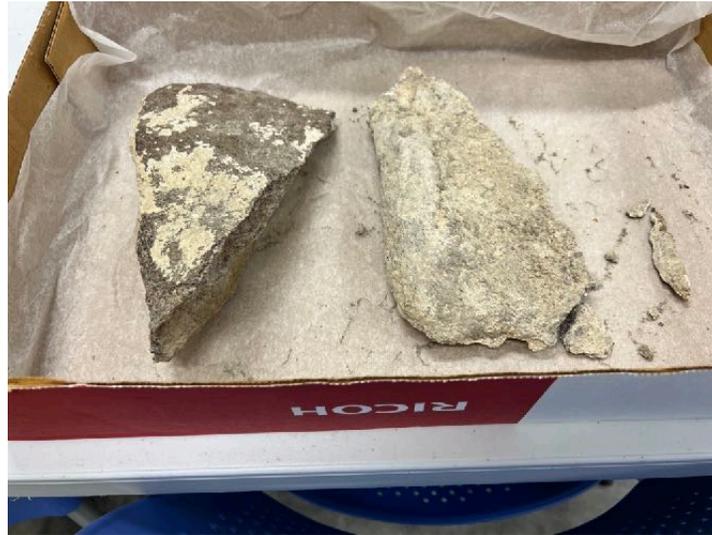
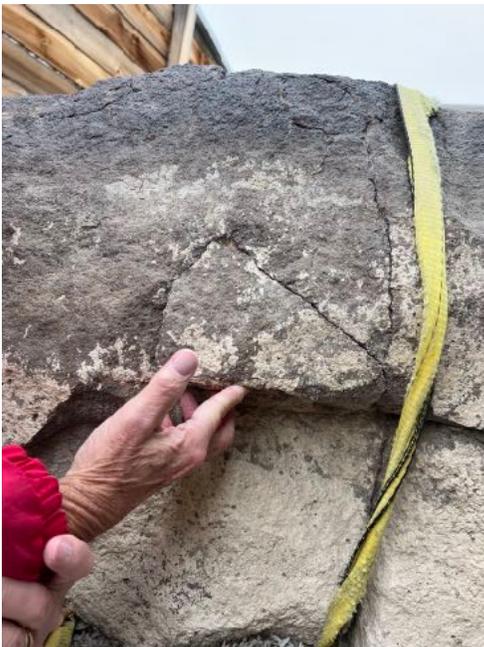
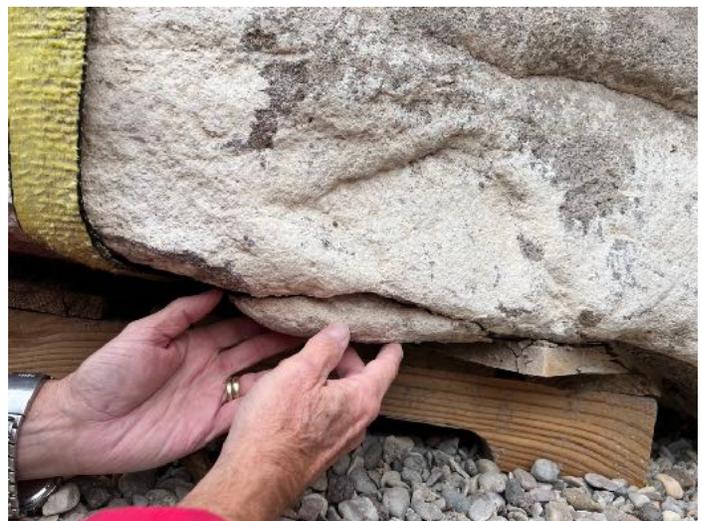
- G) Two separate roughly triangular shaped fragments measuring approximately 9"-10" in length are currently detached from the host stone and are kept in the Topaz Museum. Based on the video clips, one fragment appears to have been gravity resting from the very beginning near the cross crack (+) on the then skyward facing surface. This fragment was picked up and removed by hand. The other fragment separated from the host stone as the equipment operator was attempting to load the stone onto the wooden pallet. He noticed it, stopped work as a result, picked it up off the ground and handed to one of the other people helping with the unearthing and relocation process. The specific location of the origin of these two fragments on the north and south sides the host stone has been established and photographed. Future conservation techniques to reattach the fragments are fairly simple and straightforward.

- 4) Thoroughly document the 2 triangular shaped stone fragments. Properly label and store them in a secure location. Have a competent stone conservator re-adhere the fragments in their original location after the stone is moved to its final location.
