## CENTRAL UTAH RELOCATION CENTER (TOPAZ) WAKASA MEMORIAL STONE ASSESSMENT REPORT

August 15, 2023

Wakasa Memorial Stone  
Current Location:  
Topaz Museum  
55 West Main Street  
Delta, Utah  
United States of America

**Central Utah Relocation Center (Topaz)**  
**National Historic Landmark**  
**Condition Assessment Report**

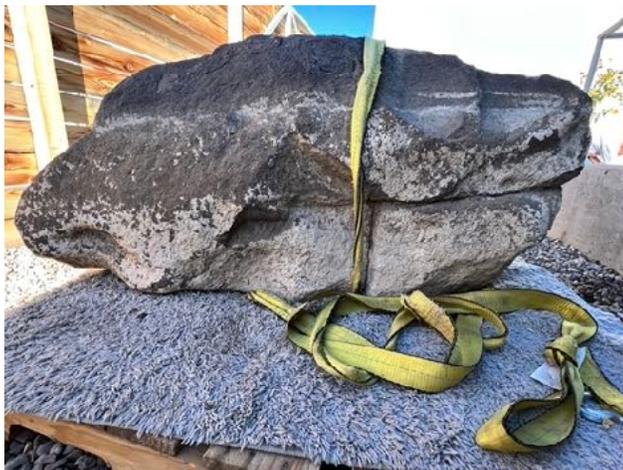
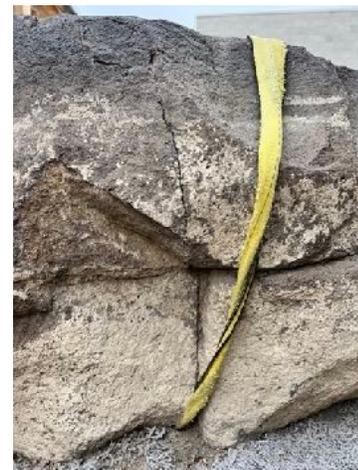
- A) The **south side** is characterized by the presence of substantial cracks and natural fissures that intersect, forming approximately 90 degree angles in a cross shape (+). The stability and cohesiveness of these fissured areas is of concern. This surface faced predominantly skyward during its approximate 80 years at Topaz. A skyward orientation for this period likely facilitated the puddling of water from rain, stone, and ice in and around the cracks. Gravitational forces likely facilitated water infiltration into the fissures. Since water expands approximately 8-9% in volume when frozen, repeated freezing and thawing cycles would exert substantial expansive force in the fissures, which often results in a weakened and less cohesive stone. The extent of the distress from this process is undetermined.

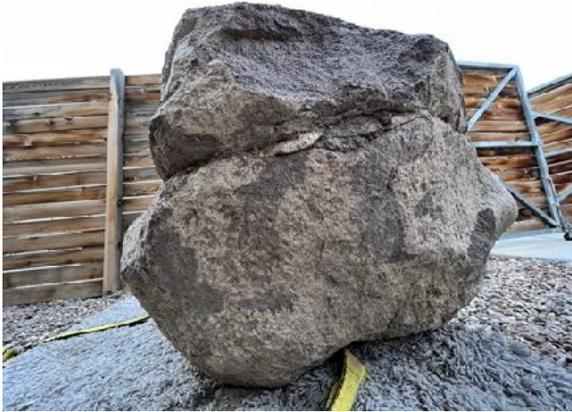
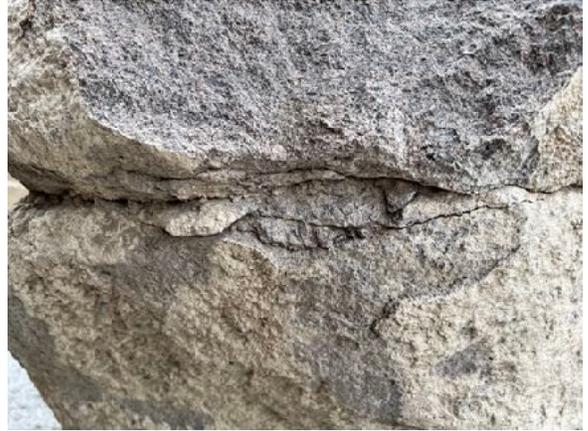
- B) The **east side** is characterized as constituting the east “end” of the stone. There is a substantial horizontal crack across its entire end that extends from the + crack on the south side.

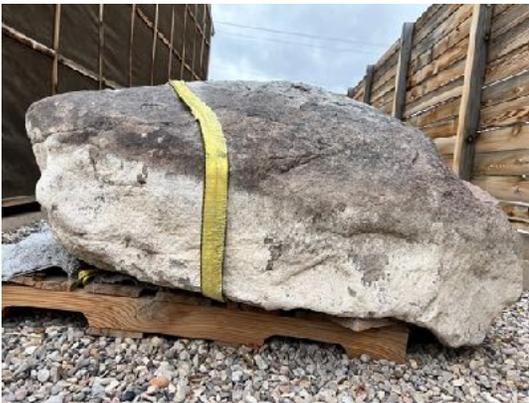
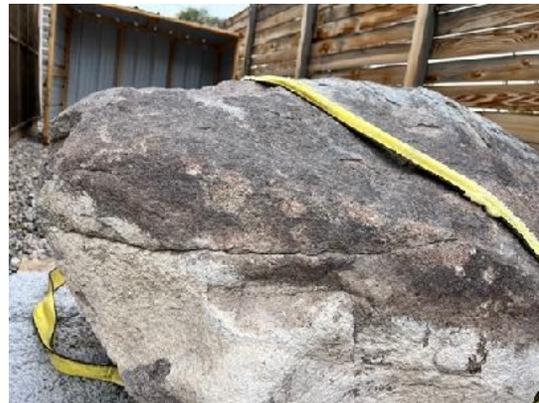
- C) The **north side** is characterized by a continuation of the horizontal crack from the south and east sides. This crack is located near the upper level of the north elevation. It fades and terminates approximately half the distance across the north side of the stone. The lower half of the north side is covered with caliche (calcification), and the remaining top half is desert varnish.

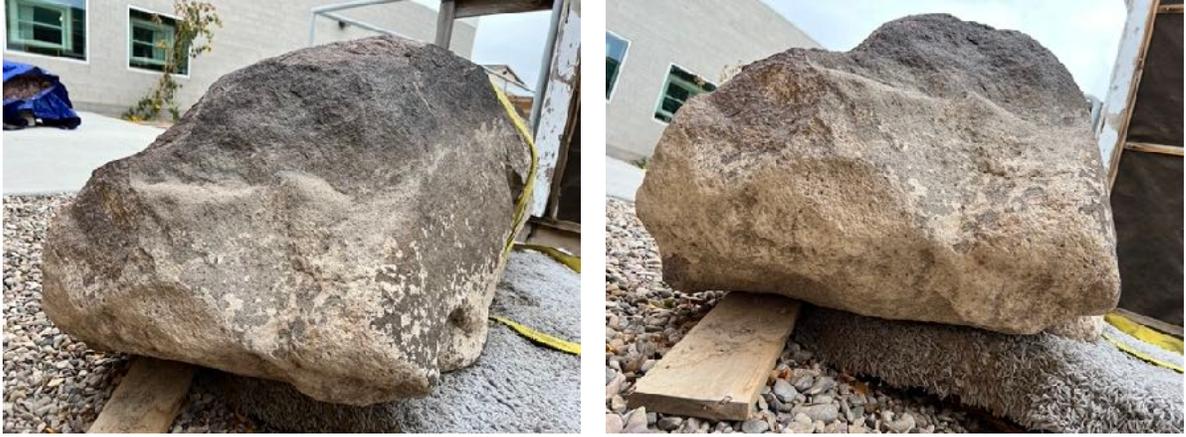
- D) The **west side** constitutes the west “end” of the stone. The defining feature on the west side is a large, awkward downward bend on the end of the stone. This unexpected dropped shape created difficulty dislodging the stone from the ground during unearthing. The downward pointing bend extends off the west end of the

pallet and below the top surface of the pallet, and is not currently supported except by a wood board the equipment operator placed at an angle under it—likely to keep the stone from rocking during loading, transporting and unloading.

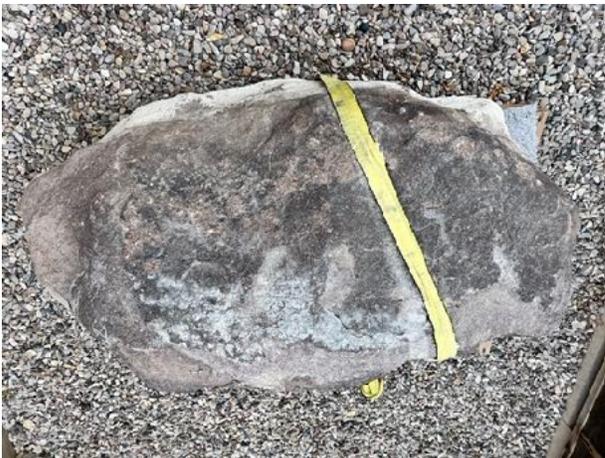
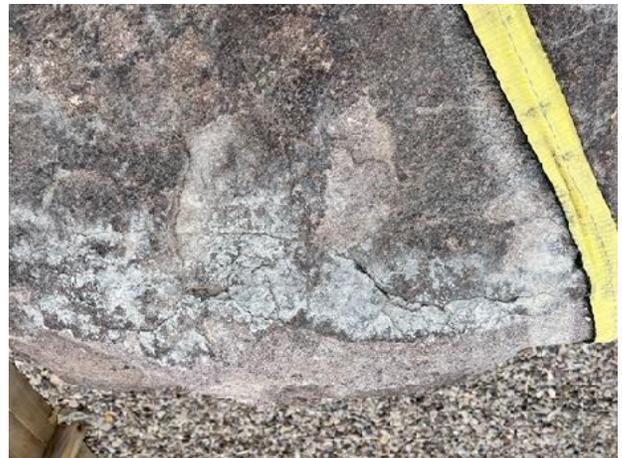
- E) The present **skyward facing surface** consists primarily of “desert varnish.” Desert varnish is described by Dr. Eric H. Christiansen, Professor of Geology at Brigham Young University in Provo, Utah, as a dark iron-manganese deposit formed by the rock surfaces being exposed to the atmosphere in arid and semi-arid environments.<sup>7</sup> There is significant loss of surface material on this side. I “sounded” the skyward / desert varnish surface by lightly tapping it with the end of hand-held metal rods, listening to the resulting sounds. Areas sounding higher in pitch are typically cohesive, while areas sounding lower in pitch typically indicate hollowness or separation of layers. Based on the results of the sounding, large areas of the desert varnish surface appear to have developed hollowness, delamination, or other distress. This condition, typical of many skyward-facing stone surfaces, preceded the unearthing and relocation of the stone.

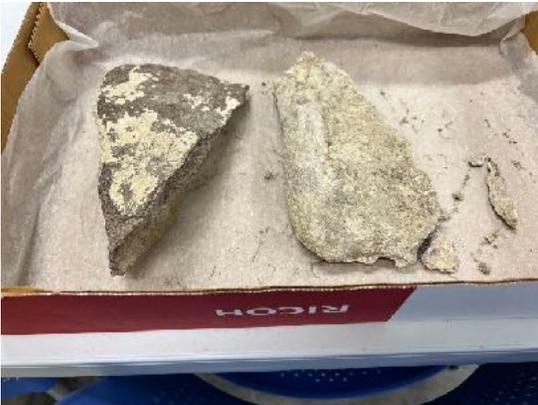
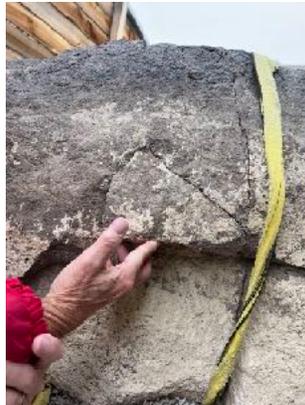
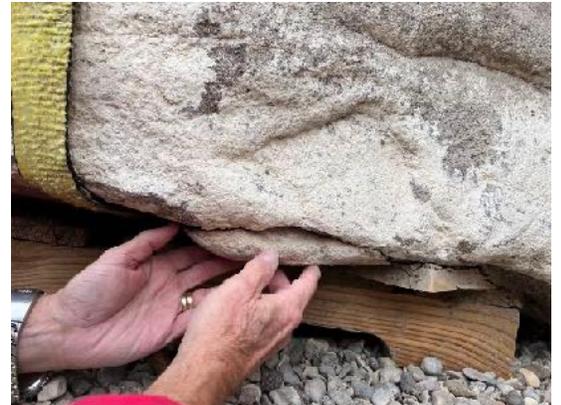
- G) Two separate roughly triangular shaped fragments measuring approximately 9”-10” in length are currently detached from the host stone and are kept in the Topaz Museum. Based on the video clips, one fragment appears to have been gravity-resting from the very beginning near the cross crack (+) on the then skyward facing surface. This fragment was picked up and removed by hand. The other fragment separated from the host stone as the equipment operator was attempting to load the stone onto the wooden pallet. He noticed it, stopped work as a result, picked it up off the ground, and handed it to one of the other people helping with the relocation process. The specific location of the origin of these two fragments on the north and south sides of the host stone has been established and photographed. Future conservation techniques to reattach the fragments are fairly simple and straightforward.

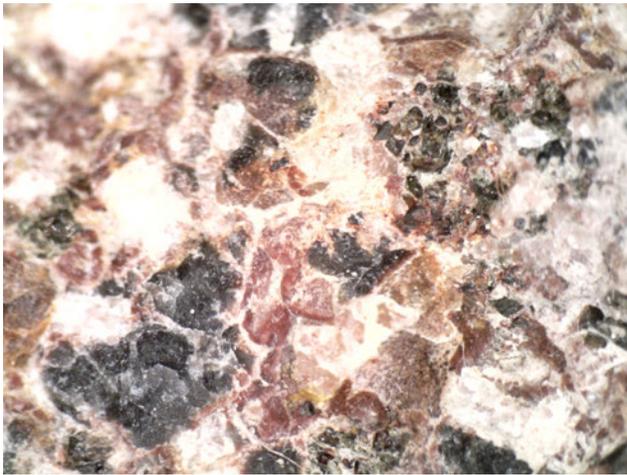
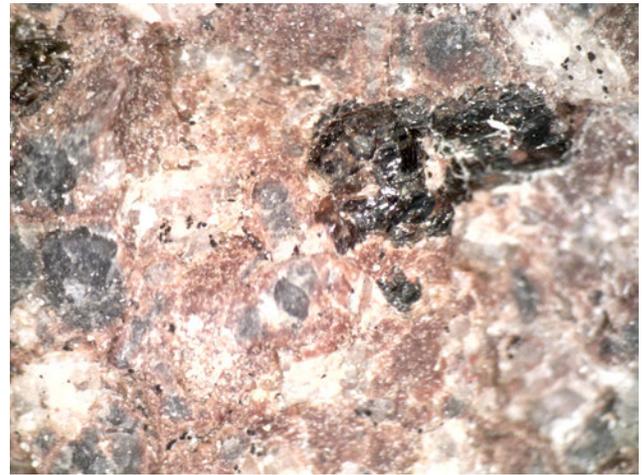
**Images 1 and 2.** Microscopic images taken of the stone surface show crystal inclusions, or phenocrysts, that can be indicative of rhyolite common to the area.

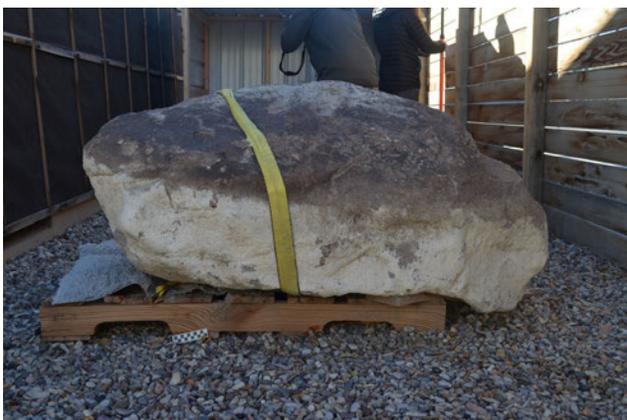
Roughly half of the stone lengthwise exhibits what appears to be a thin white mineral coating (Images 3 and 4). The coating covers most of the area that was exposed before the stone was moved, but based on pre-movement photographs, also covers a good deal of surface area that was underground. In some places the mineral coating extends as much as 30cm beyond where the stone was exposed when it was *in situ*. The north face of the stone<sup>21</sup> shows a distinct linear boundary for the coated area, while this boundary is less defined on the other faces. Without further analysis, it is difficult to know the composition of the mineral coating and whether it was deposited over time while the stone sat partially buried, or if it leached out of the stone itself as a result of water saturation and subsequent evaporation over many years. It is also impossible to know at this time whether the coating developed after the stone was moved to its location at Topaz, or whether it was extant when the stone was taken to that site from its original location.

**Image 3.** North face of the stone showing roughly linear boundary of mineral surface coating.

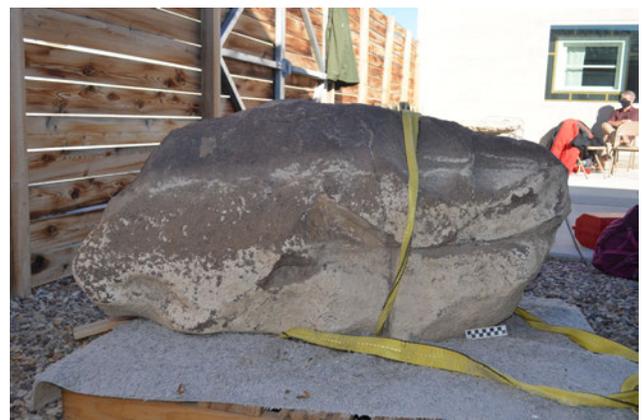
**Image 4.** South face of stone showing irregular boundary of mineral surface coating.

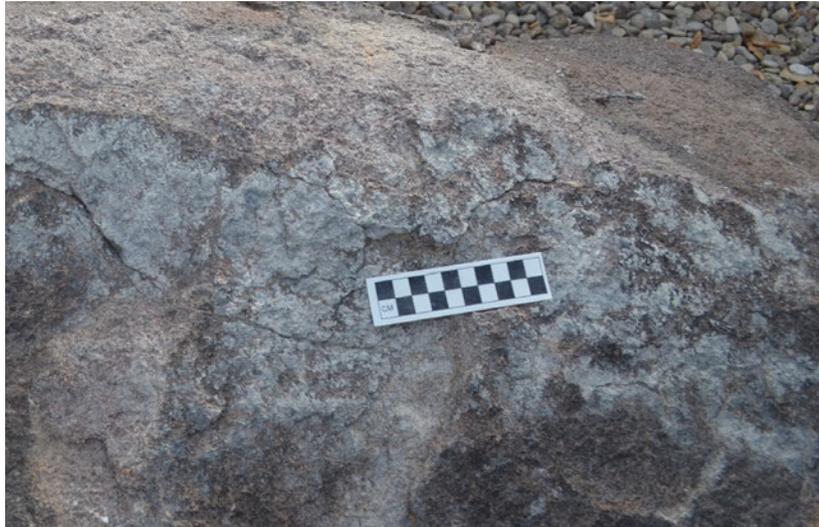
There is evidence of a blue-gray mineral deposit on the current top surface of the stone, which would have been the most deeply buried portion when the stone was *in situ* (Image 5). As with the white mineral coating, it is impossible to know the composition of this coating without further analysis.

**Image 5.** Blue-gray mineral deposit on the current top surface of the stone.

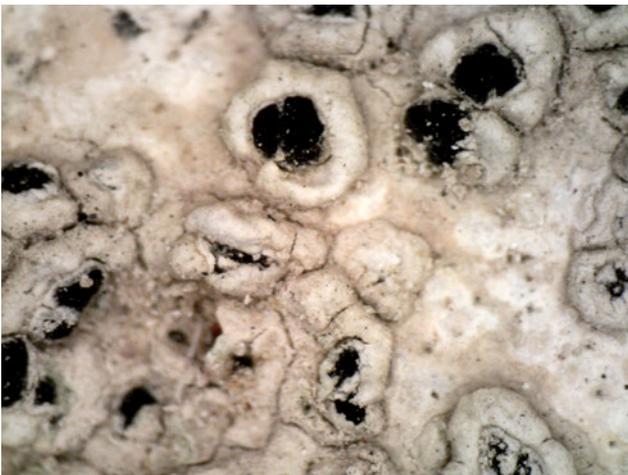
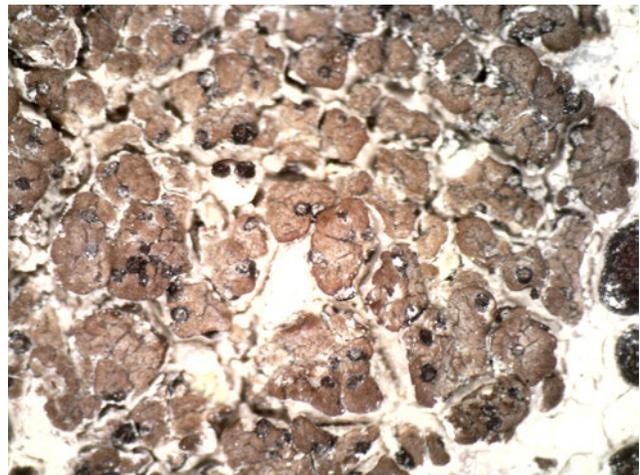
Several species of lichen were seen growing on the stone surface (Images 6 and 7). All were crustose in nature and covered very small areas. Lichen growth appeared to be concentrated in areas of the stone that contained divots or depressions, which would have collected water and made for a more hospitable environment when the stone was *in situ*. The lichens do not appear to be causing any noticeable damage to the stone.

**Images 6 and 7.** Microscope images of two different lichen species found on the surface of the stone.

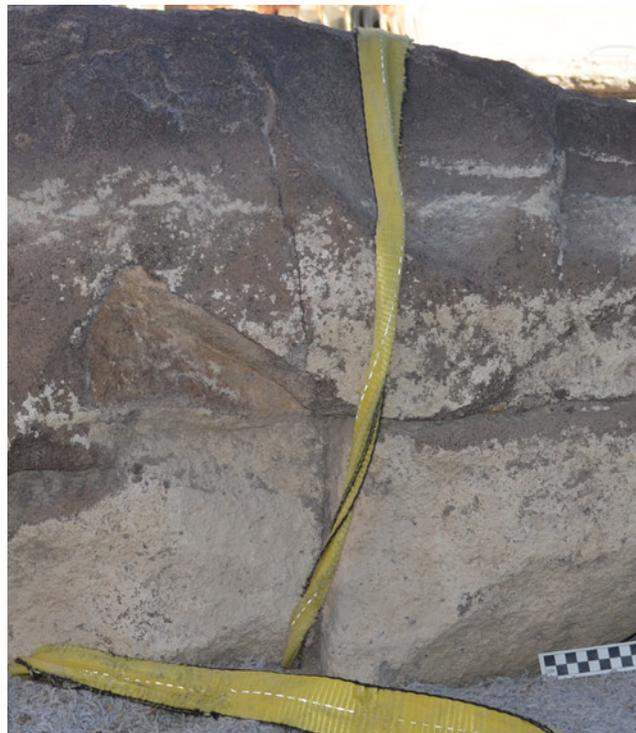
The south face of the stone exhibits two large fractures, one vertical and one horizontal, that converge to the east of that face's midpoint (Image 8). These fractures are visible, but narrow, and while there has been previous loss in that area (to be discussed in the next section), it now appears to be stable. The vertical crack continues to the top face of the stone, where it joins a network of surface cracks that are discussed at the end of this section.

**Image 8.** Intersecting fractures on south face of stone.

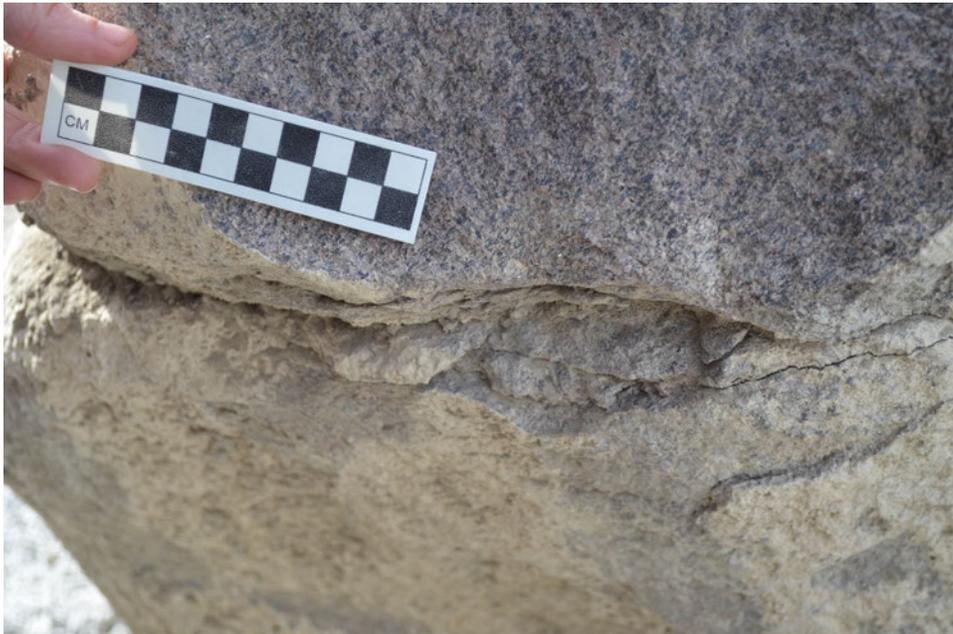
The horizontal crack on the south face of the stone continues around to the east face, where it grows wider and less stable. Here the fracture splits into several smaller cracks, creating layers of delaminated stone fragments within an area that may previously have suffered surface loss (Image 9). This area terminates as the fracture narrows again and continues around to the north face.

**Image 9.** Fracture on east face of stone running through area of previous loss and delaminating stone fragments.

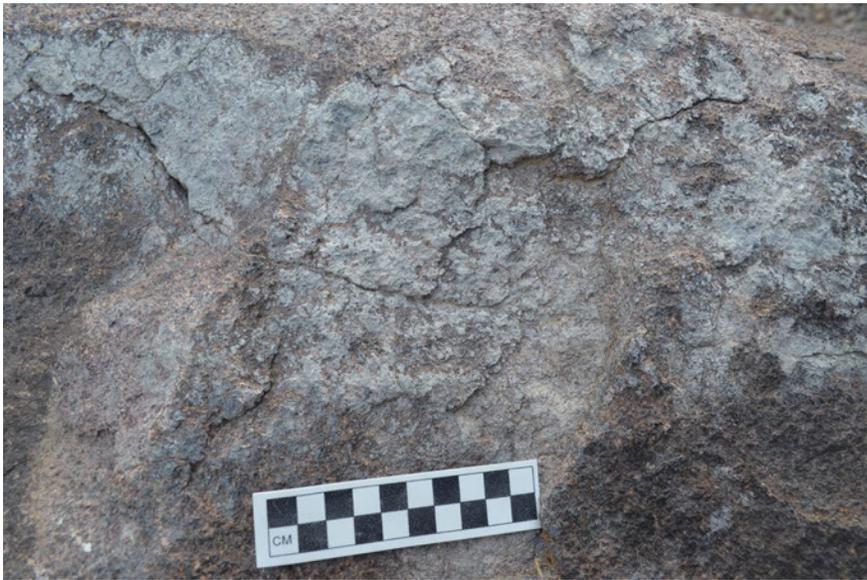
The top surface of the stone as it is currently positioned exhibits a rounded ridge that runs the length of the face. This ridge exhibits multiple intersecting fractures that appear to affect only the surface layers of stone, but these fractures may indicate that those surface layers are becoming detached from the larger stone mass. Several areas of this ridge sounded hollow when tapped with a fingernail, while more stable areas of the stone did not. This network of cracks that runs along the top ridge of the stone (Images 10-12) is currently the area of the stone most vulnerable to damage and loss.

**Image 10.** Network of cracks on north face of ridge running along top of stone.

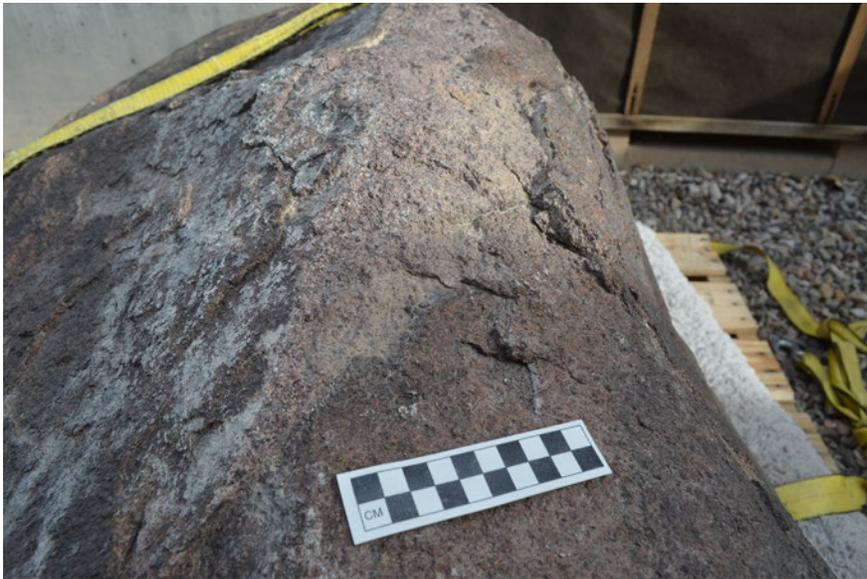
**Image 11.** Network of cracks along top ridge of stone viewed from the west.

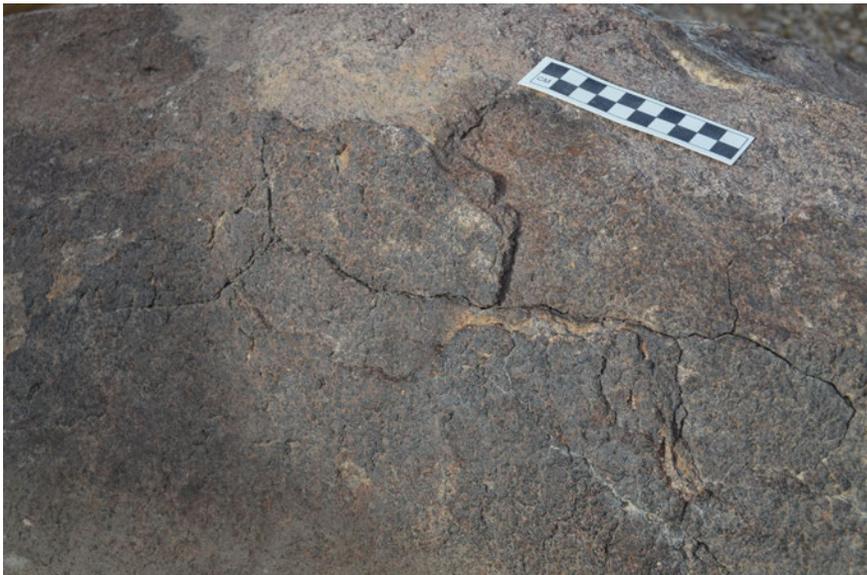
**Image 12.** Network of cracks along top ridge of stone on south face.

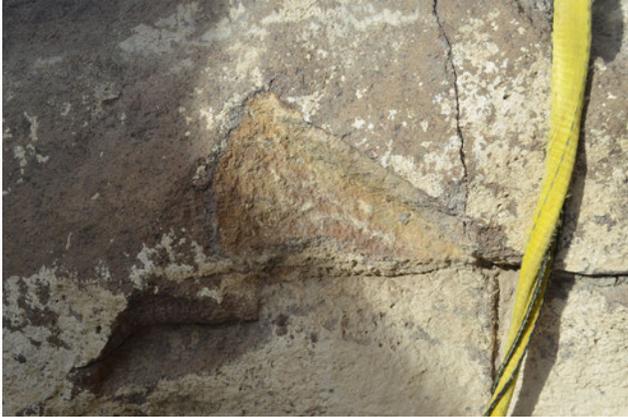
There are several areas of the stone that exhibit evidence of previous material loss. While it is unknown when most of this loss occurred, two areas were described and shown to the NPS research team as having occurred during the removal of the stone from its previous site. These areas are on the south side of the stone at the juncture of the two previously discussed fractures (Image 13) and on the north side of the stone on what is currently the underside closest to the ground (Image 14). The pieces that detached from the main body of the stone during its removal were collected and are currently stored in the collections of the Topaz Museum (Image 15).

**Image 13.** Area of recent loss on the south face of the stone.

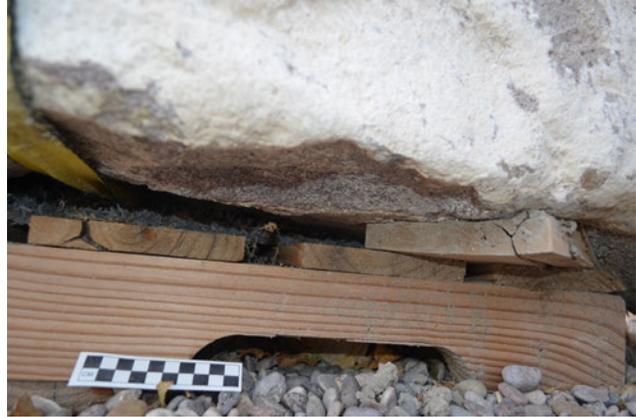
**Image 14.** Area of recent loss on the current underside of the north face of the stone.

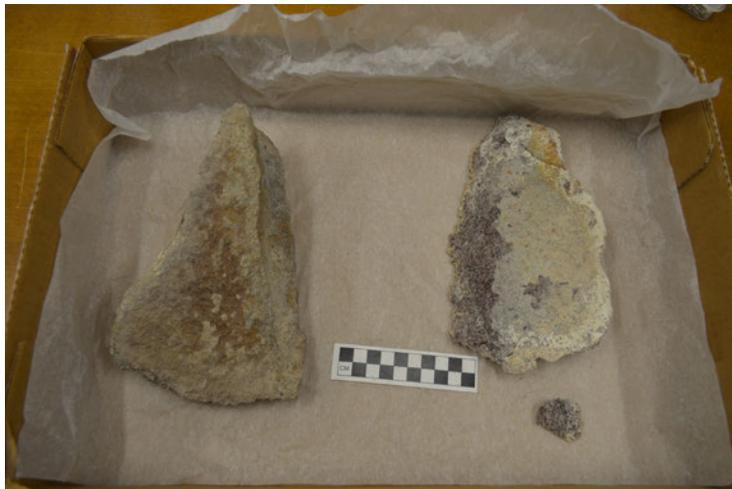
**Image 15.** Fragments that detached from the stone during its removal.

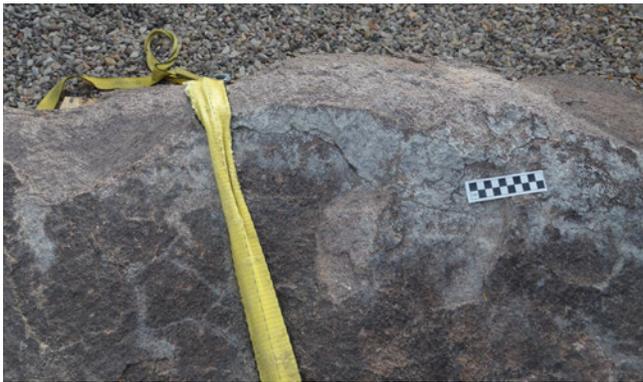
Finally, stone fragments found at the site where the stone was removed match the color and texture of areas of the main body of the stone that exhibit evidence of loss (Images 18 and 19). It is possible that these fragments were originally part of the main stone body and became detached at some point between when the stone was placed on site at Topaz and when it was removed for placement at the Topaz Museum.

**Image 16.** Ridge at the top of the stone that exhibits evidence of loss. Note the abrupt changes in color and surface topography, especially on the left side of the picture.

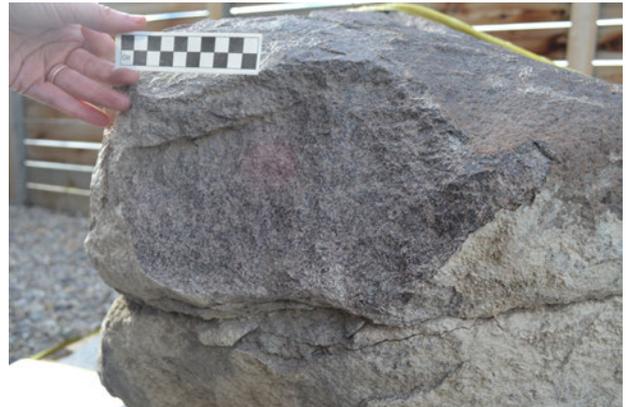
Another area that exhibits potential loss is on the east face of the stone, near the top (Image 17). Again, an abrupt change in color and sharply defined surface boundaries indicate sudden loss of a piece of stone, as opposed to gradual erosion of an area.

**Image 17.** Potential surface scar indicating loss on the upper part of the east face of the stone.

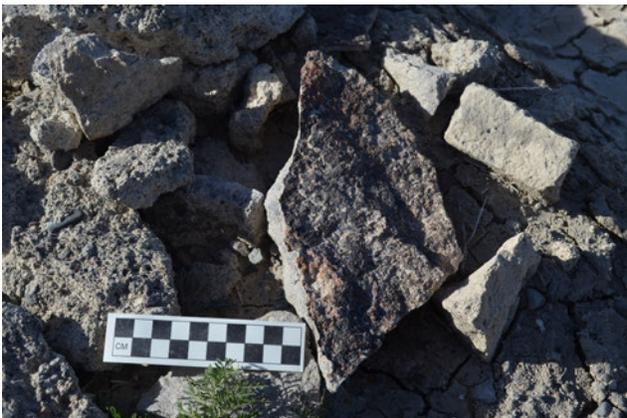
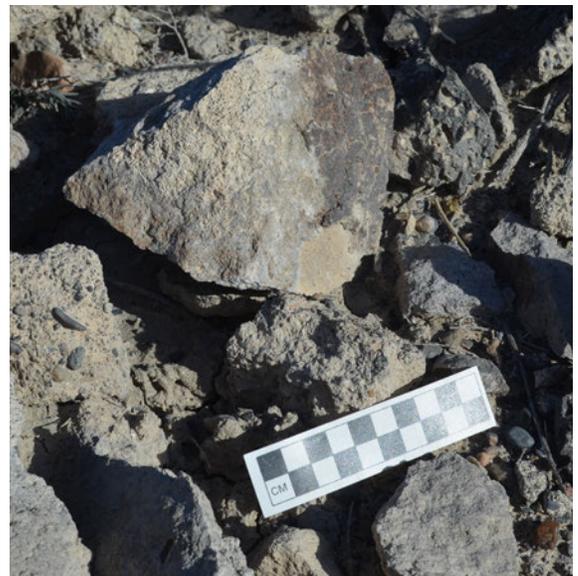
**Images 18 and 19.** Stone fragments found at the removal site that may have originally been part of the larger body of stone.

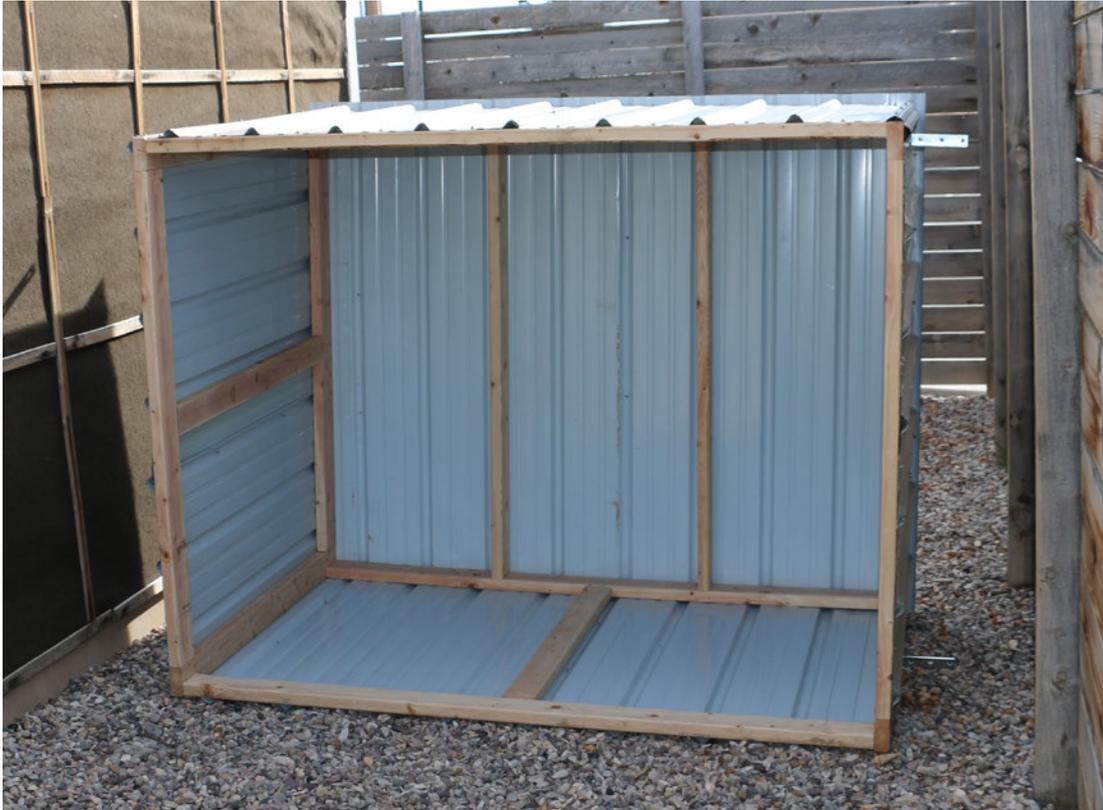
"Interior of Storage Structure, turned onto its south-side.

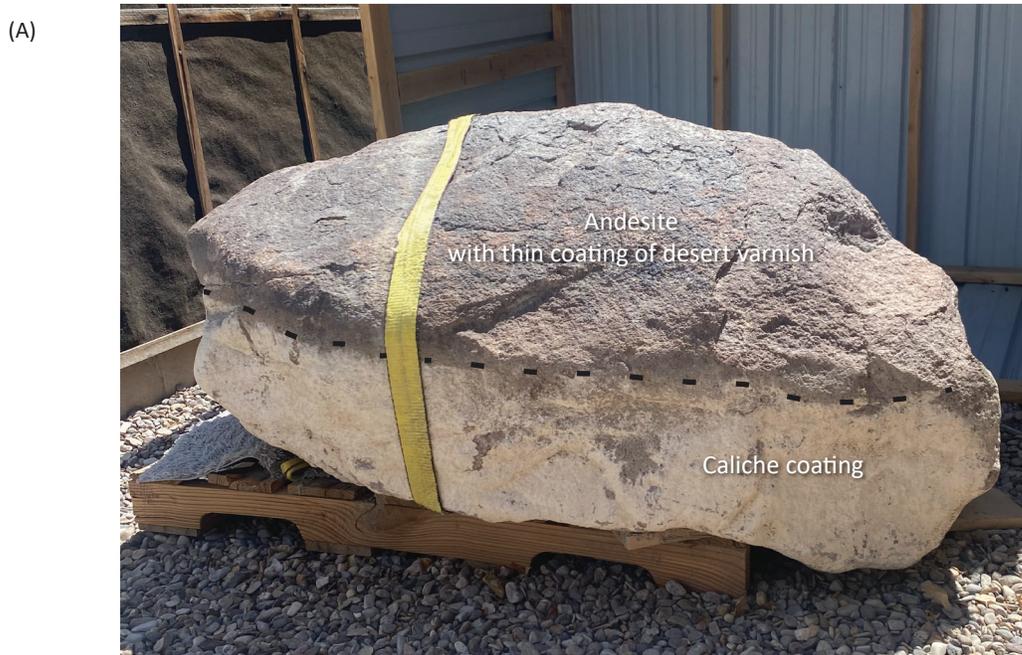
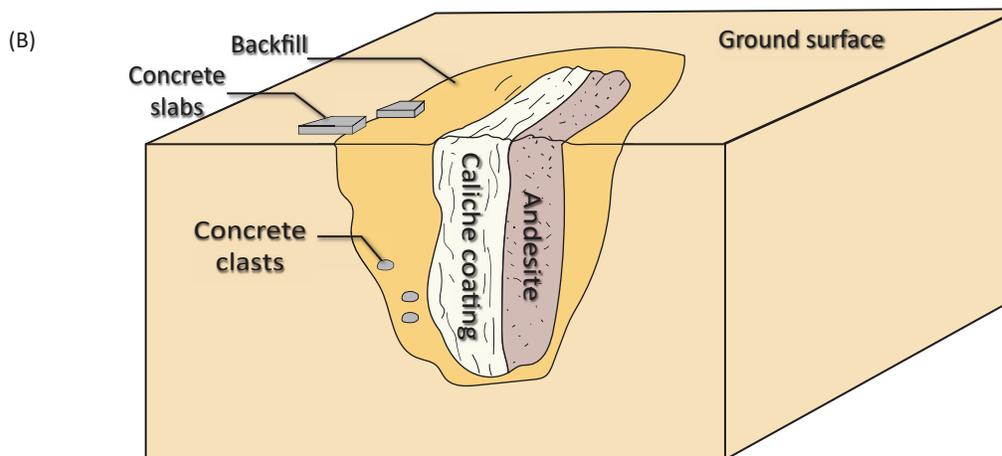
Figure 1. (A) The Wasaka stone at the Topaz Museum, Delta, Utah. The boulder is made of andesite--a common volcanic rock in western Utah. The andesite is exposed at the top of the boulder and has a coating of desert varnish. The bottom part of the boulder is light-colored because it is coated with caliche--a deposit of calcite and other minerals formed from groundwater when the stone was partially buried. The top of the band is nearly horizontal and reveals that thousands of years ago, during the formation of the caliche coating, the boulder was oriented much like it is now. (B) When found buried on the Topaz site, the top of the boulder was oriented as shown in this block diagram. The once horizontal caliche-coated surface was vertical before it was excavated. This is clear evidence that the boulder was moved from its original orientation. Slabs of concrete were found near the buried boulder and some pieces of concrete were also taken from the hole.

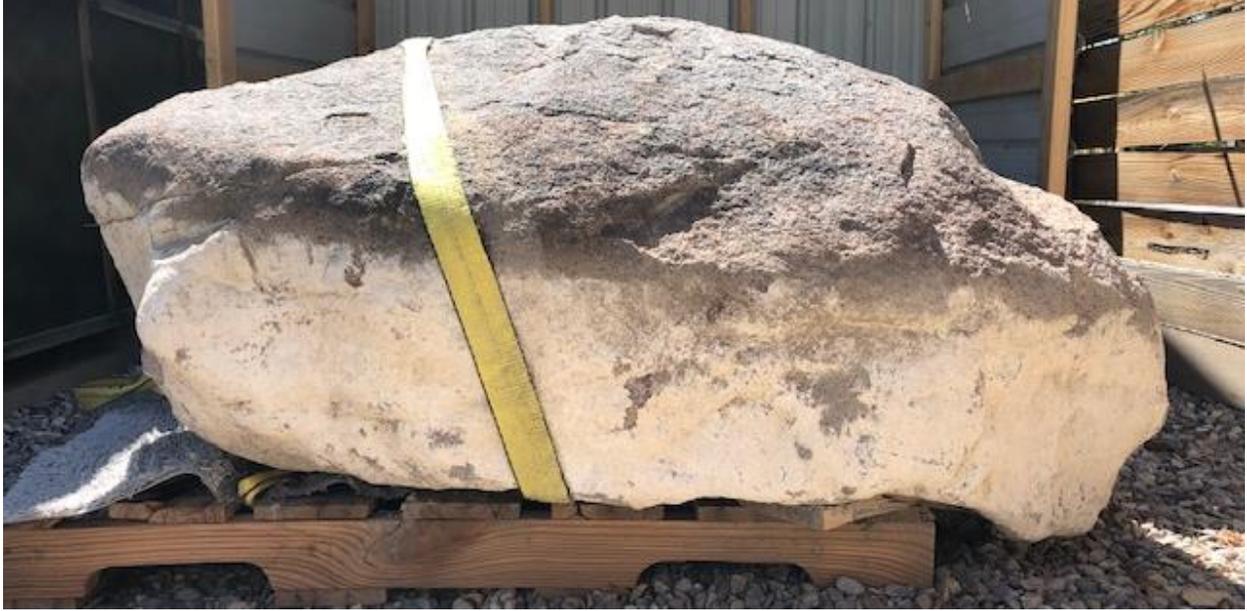
Fig. 1: Face A

The stone measures approximately 145cm x 80cm x 60cm. Photographs below of the 4 sides and top surface of the stone are labeled Face A-D, moving in a counter-clockwise direction in alphabetical order.

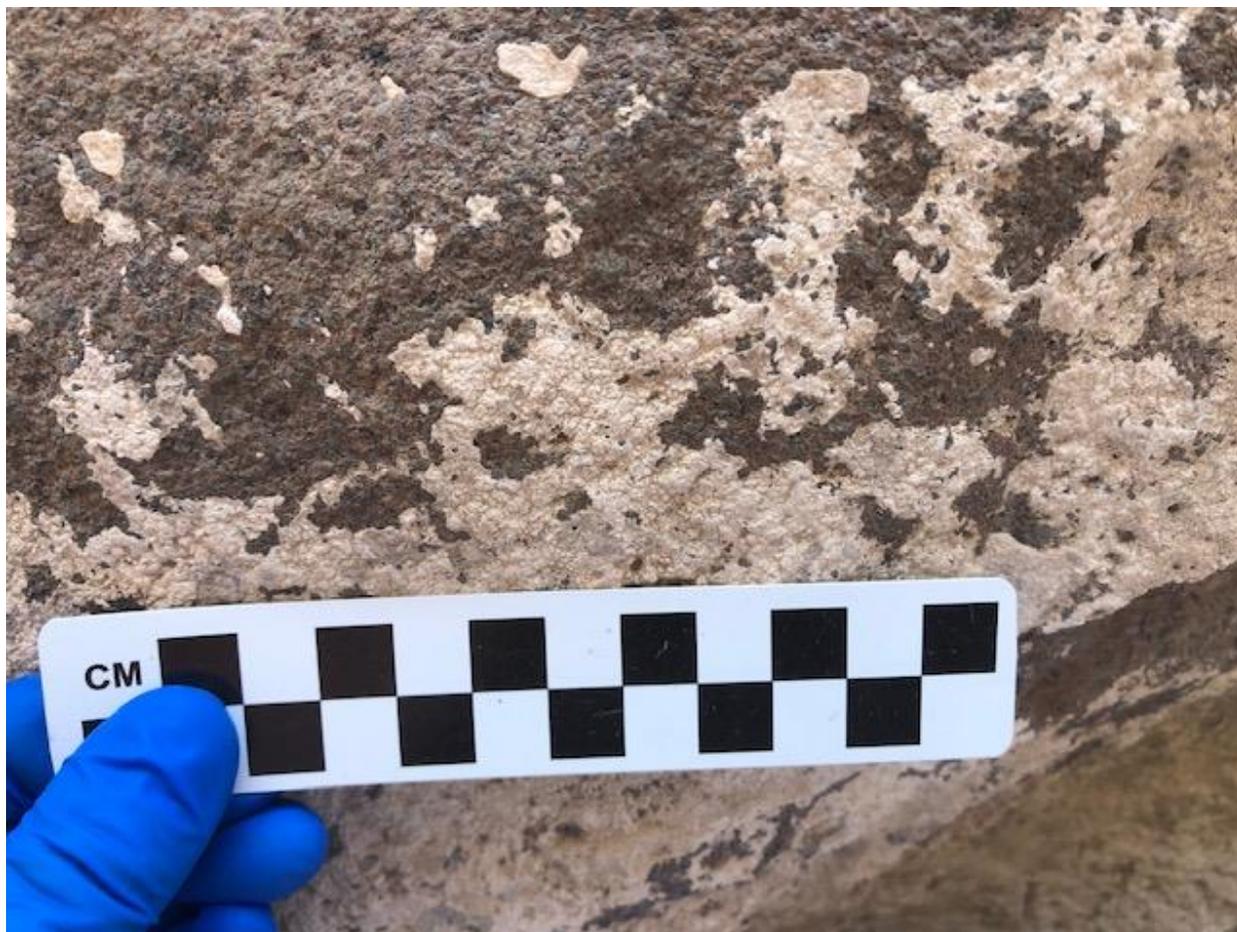
Fig. 5: Detail of white layer visible on lower half of stone as it was observed in-situ.

A **white layer**, uniform in aspect and compact in consistency, roughly 1mm in depth, is adhered to the surface, yet when tested in a discrete microtest, the layer comes off without leaving a trace on the stone beneath. This layer covers the lower half of the stone (meaning lower half, when observed in-situ in the courtyard of the museum in August 21, 2022, on palette and carpet). A deep horizontal **crack**, measuring 67cm in length, appears to travel about half way through the stone (see Figure 1: the crack is visible on the left side and center). This is based on observation and was not tested. The horizontal crack continues 45cm on the other side of the stone and **intersects with a vertical crack** that measures 60cm from the bottom surface (touching the ground) upwards (see Figure 3). There is slight **delamination** of the stone in some areas as well as two areas of loss that were indicated. There is a fragment from one of these areas of loss that is conserved separately.

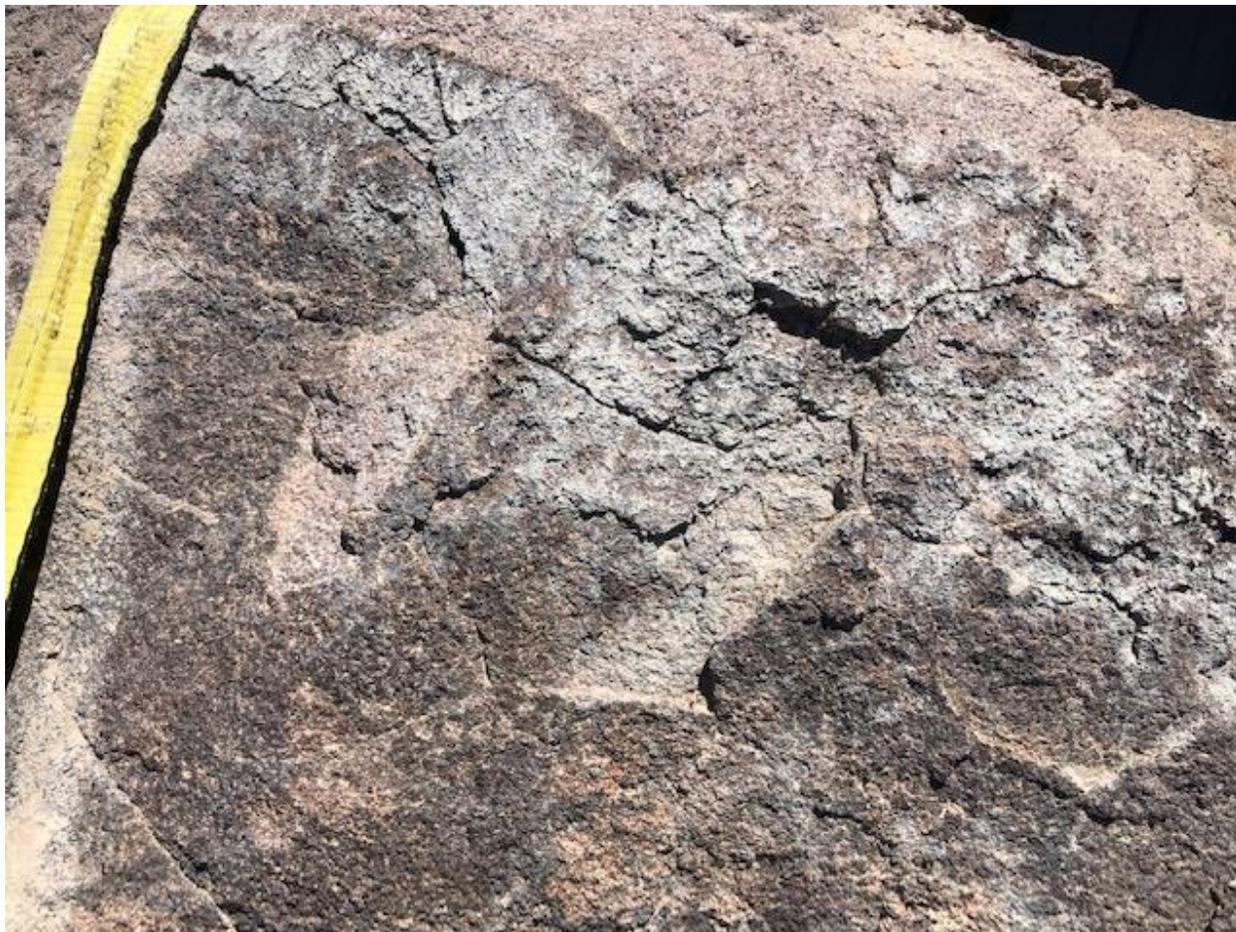
Figure 6: Detail of surface of the stone showing layers of stone that have delaminated.

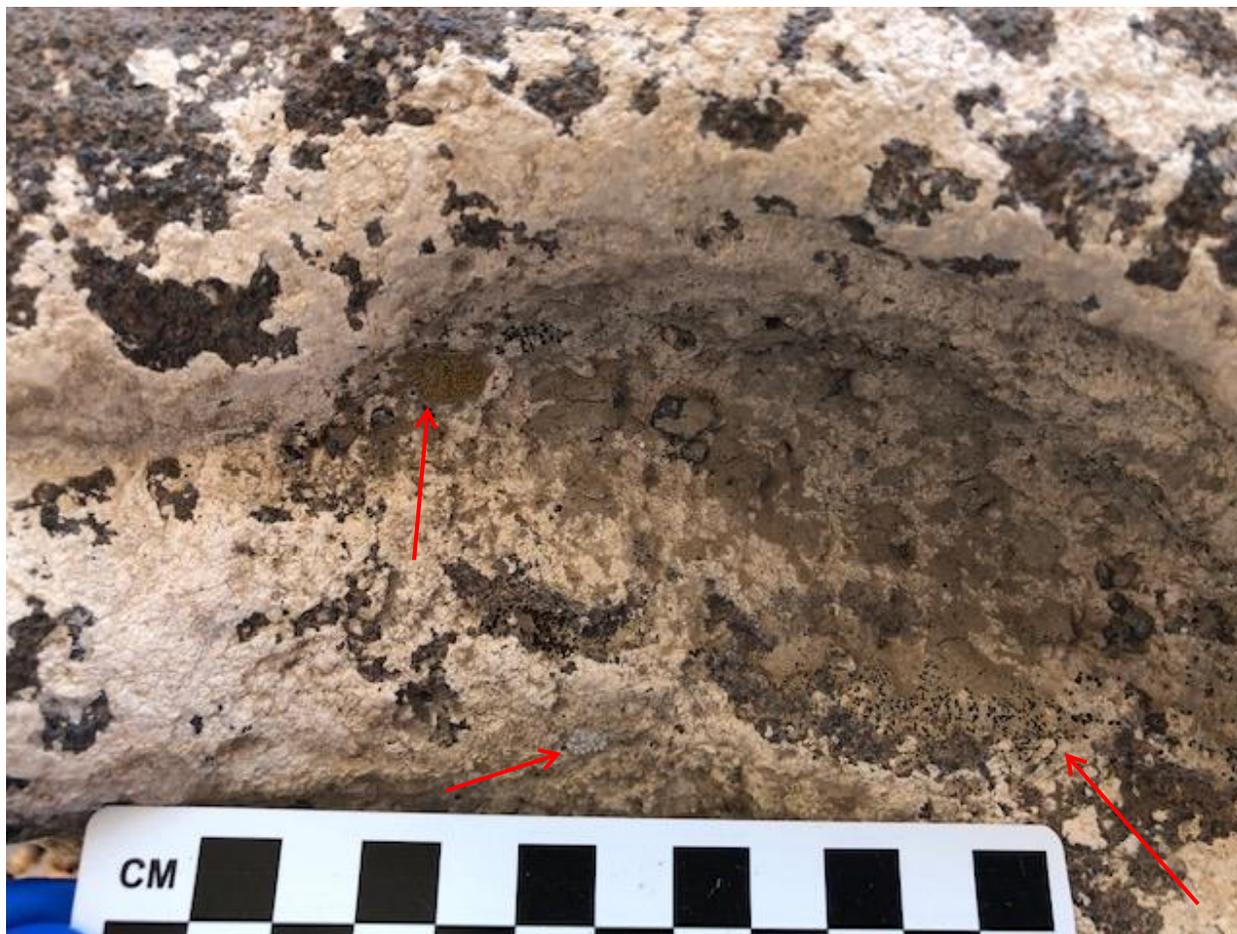
There is **some biological growth** on the lower side of the stone near the ground. This includes three different types: one blueish-grey, another in the form of small black dots, and another that appears yellow. These are very localized and do not appear to be spreading as they were observed again on Sep. 10<sup>th</sup>, two weeks after the first observation, with no change. Treatment is straightforward and would simply require application of a biocide treatment to make sure it is not live, and then mechanical removal using scalpel under magnification.

Figure 7: Detail of biological growth at lower bottom left corner of Face C (figure 3). One can see the 3 different types observed and described in the text. Although the growth was not identified when observed, identification of samples may be achieved using micro-tests and image comparison.

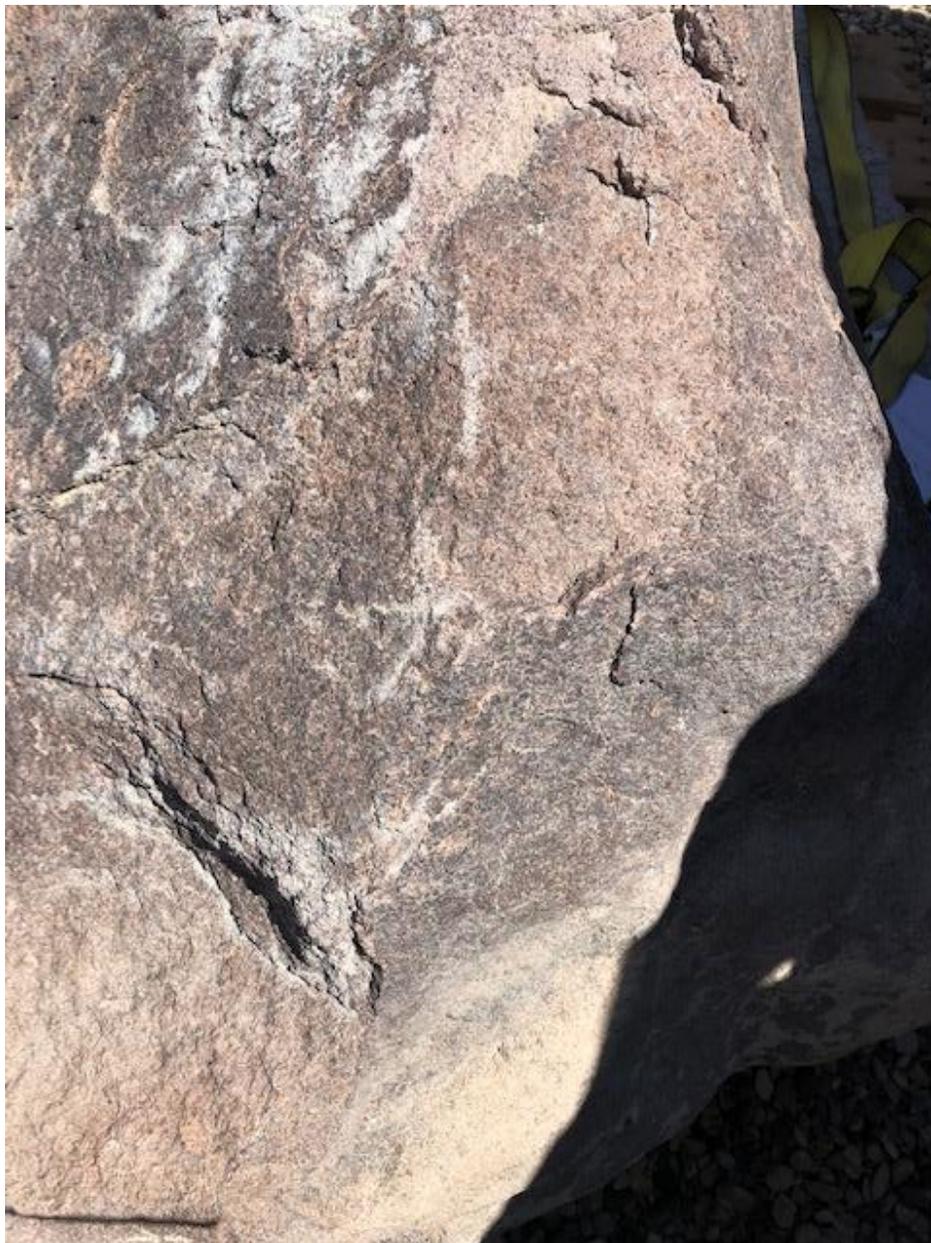
Figure 8: Unidentified white linear traces observed on upper surface of stone that do not resemble the white layer.
